**A . Report Title: SOHO MISSION INTERRUPTION JOINT  
NASA/ESA INVESTIGATION BOARD**

**SOHO Mission Interruption Joint NASA/ESA  
Investigation Board**

**Final Report**

**August 31, 1998  
SOHO Mission Interruption Joint NASA/ESA  
Investigation Board**

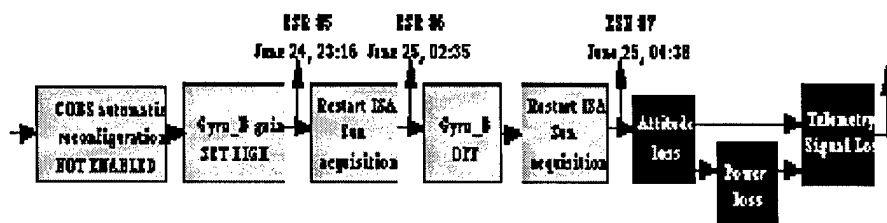
Diagram 1. Failure Event Tree - Top Level

The first two errors were contained in predefined command sequences executed from the Ground System, while the last error was a decision to send a command to the spacecraft in response to unexpected telemetry. The sequence of these errors and their relationship to the triggered-ESRs are graphically depicted in Diagram 1.

Following the momentum management maneuver, Gyro B, which is used for fault detection, was erroneously left in its high gain setting, resulting in an indicated roll rate of 20 times greater than actual. **The incorrect gain was due to an error in another predefined command sequence; this error resulted in an on-board fault detection output that triggered an ESR.** This ESR, the 5th since launch, occurred at 7:16 PM EDT (23:16 UT), June 24, 1998.

During ESR-5, the control Gyro A was not active because of the first error referenced above; however, there is no evidence or belief that any anomalous spacecraft behavior had occurred. As per design, the ESR event resulted in a reconfiguration of the gyros. Gyro A replaced Gyro C as the roll gyro used for the ESR thruster-based control mode, while Gyro B remained configured as the fault detection gyro. The error in Gyro B's gain was discovered and corrected, but the Gyro A despun status was not identified.

After transitioning to the ISA mode as part of the normal ESR recovery sequence, the attitude control system began integrating the gyro drift rate bias associated with the still despun Gyro A. After 15 minutes, this resulted in roll thruster firings intended to null the apparent (but non-existent) roll attitude error. In less than one minute, the roll rate was sufficiently high to trigger the Gyro B based fault detection once again, resulting in ESR-6 at 10:35 PM EDT (02:35 UT), June 24, 1998.

Although the spacecraft remained Sun-pointing within nominal limits and was therefore in a power-positive and thermally-safe attitude, the state of the spacecraft was precarious at this point in time. It had an anomalous roll rate and was depending on a deactivated gyro for roll control in both ESR and ISA modes. The personnel on the ground were not aware of either of these facts at that time. Gyro C was correctly configured to the ACU since the reconfiguration at ESR-5. Gyro B was active and on-line for fault detection, and it was correctly measuring the anomalous roll rate. A rapid decision was made that Gyro B was faulty because its output disagreed with the rate indicated by Gyro A. This decision led to the commanding off of Gyro B.

During ESR-6 recovery, Ground Operations commanded the spacecraft to ISA mode. In ISA, the attitude control system resumed firing roll thrusters in an attempt to null the attitude error associated with the electrical rate bias term of the despun Gyro A. Gyro B and the associated fault detection were now inactive. The increasing roll rate eventually resulted in pitch and yaw Sun-pointing errors that exceeded a prescribed limit of five degrees, resulting in ESR-7 at 12:38 AM EDT (04:38 UT), June 25, 1998. Due to the gyroscopic cross-coupling torques caused by pitch and yaw thruster firings, and the absence of true roll rate indications, the ESR controller was no longer stable, and the spacecraft attitude diverged. **The incorrect diagnosis of a Gyro B fault and the subsequent ground response to this diagnosis ultimately resulted in loss of attitude control, subsequent loss of telemetry, and loss of power and thermal control.** Loss of telemetry occurred at 12:43:56 AM EDT (04:43:56 UT), June 25, 1998. It can not be determined whether this loss was a consequence of insufficient power or a loss of communication link caused by spacecraft attitude.
